## **Efflorescence on clay bricks masonry: towards a new test method**

**Ch. de Bueger, F. de Barquin**

TT1-251

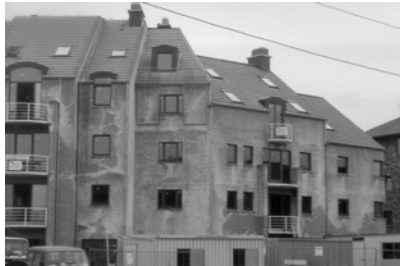
**Figure 1. Example of efflorescence apparition at the end of work.**

Efflorescence appears generally on the surface of veneer wall build with porous material as clay bricks under an aspect of deposit of white powdery or foggy salts. The baneful consequence of this salt apparition is considered mainly as an aesthetic problem. This phenomenon often arrives just after the end of the construction (see 'Fig. 1') always generating confusion in the attribution of responsibilities between the different parties involved: brick provider, mortar provider, contractor, designer and customer. Sometimes, efflorescence appears few years after the end of construction leaving the building owner face to questions about cleaning or maintenance. In some cases, this salt apparition can be very persistent and hard to remove [Brocken *et al.* 2004].

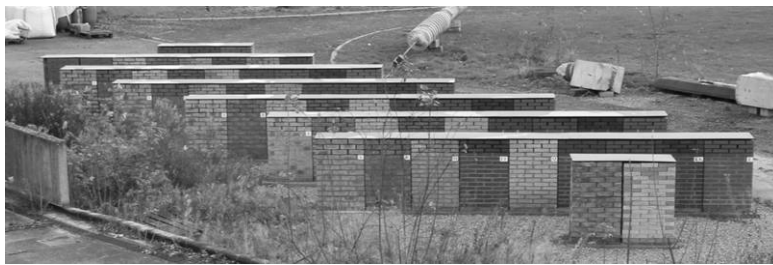
**Figure 6. Exposure site.**

The optimisation of the drying conditions is really important. A too hard drying could carry away the crystallisation inside the brick and not on the surface. A too light drying could not cause crystallisation. To find out the optimal drying conditions, we have used an exposure site (shown in 'Fig. 6') with among other the selected brick/mortar combinations except the combination with the mortar M14. For each of them, two walls, one in the SW and the other in the NE direction, are built. The walls are 65 cm wide and 1m high. The three last layers of the wall are not assembled with mortar but by a rubber joint to see the behaviour of the brick alone.

Near this exposure site, a meteorological station records every ten minutes the climatic conditions: temperature [°C], relative humidity [%], wind direction, wind speed [m/sec] and sun radiation [W/m<sup>2</sup>K]. Every day, a visual survey allows to see which wall shows

efflorescence. This information is completed by three webcams that record every hour the evolution of three walls assumed to be really sensitive to the efflorescence apparition. Finally, some walls are fitted out with thermocouples placed inside the masonry in order to evaluate the thermal gradient. Three thermocouples by wall are used: one on the surface, one in the centre and one near the back of the wall.

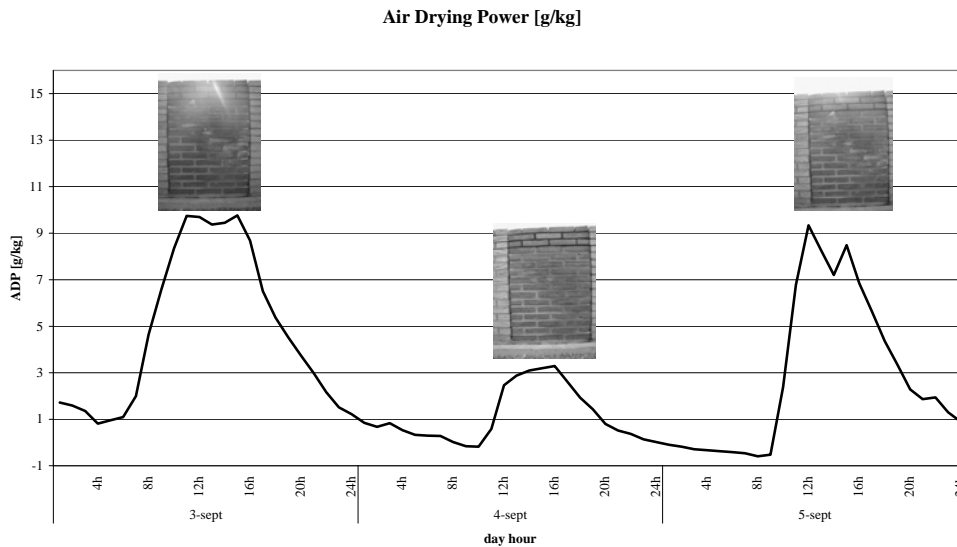
Figure 7. ADP graphic coupled with visual data of one wall of the exposure site.

'Figure 7' shows an example of the coupled visual and ADP data. The survey is here reported for a period of three days in September 2002. The 3<sup>rd</sup> and the 5<sup>th</sup> September, the ADP was more than 9 g/kg and the pictures, taken at the middle of the day, show that there is efflorescence on the wall. On the

other hand, the 4<sup>th</sup> September the ADP was less than 4 g/kg and the picture for the same wall doesn't show efflorescence.
